## TEST REPORT

No. : XMIN2505001149CM01\_EN

Sample Name : Safety Flooring Homogeneous Vinyl Sheet

### 1. Test Item: Anti-Slip Property

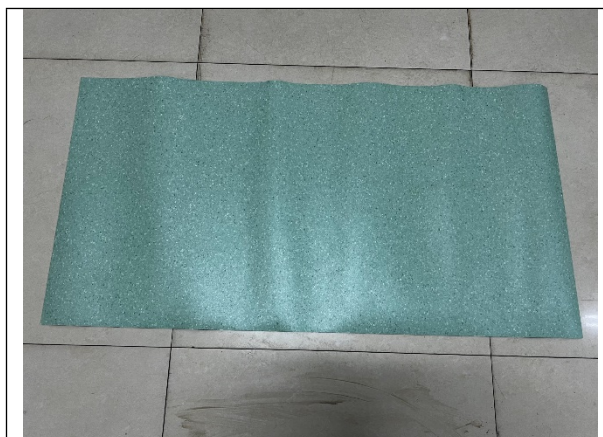
### Original Sample Photo:

Material : PVC

Sample Description: See photo

Specimen: 1000mm×500mm, 1pc, see photo

Test surface: see photo
